MOSS NO. 1 FRESH WATER SUPPLY DAM

DICKENSON COUNTY, VIRGINIA

VA. NO. 05103

PHASE I INSPECTION REPORT NATIONAL DAM SAFETY PROGRAM

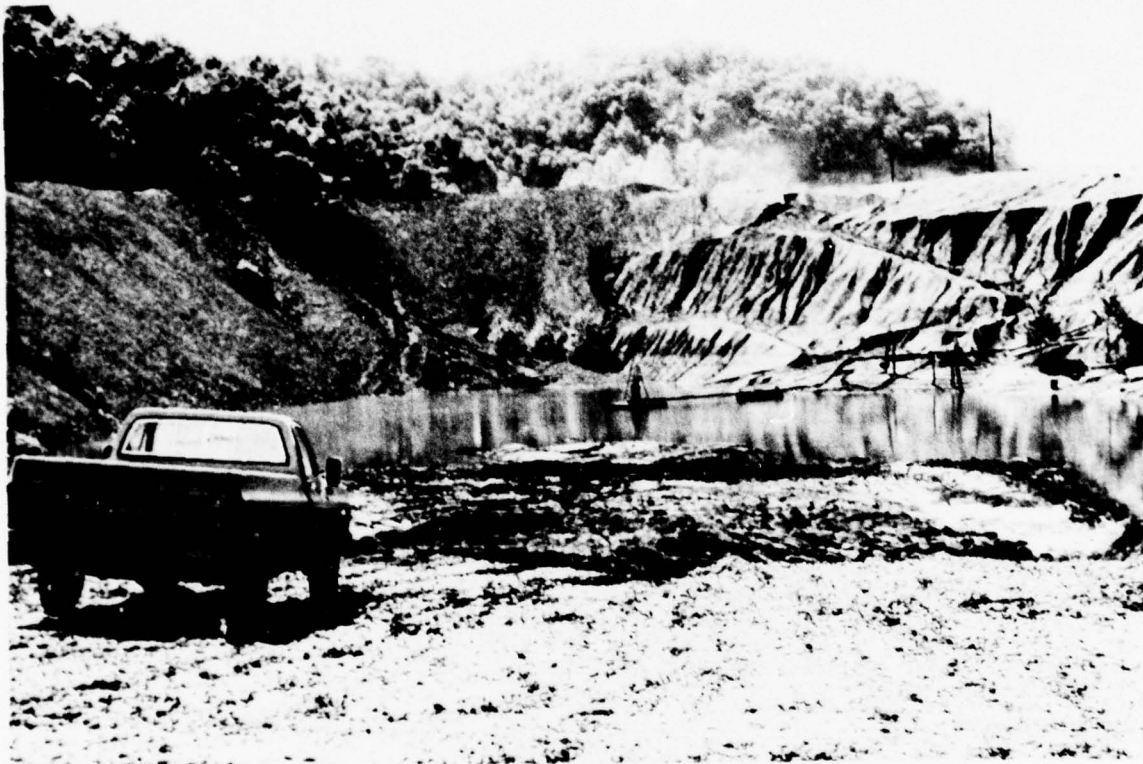
OVERVIEW PHOTO

(View looking at upstream face of berm
and arrow denoting principal spillway.

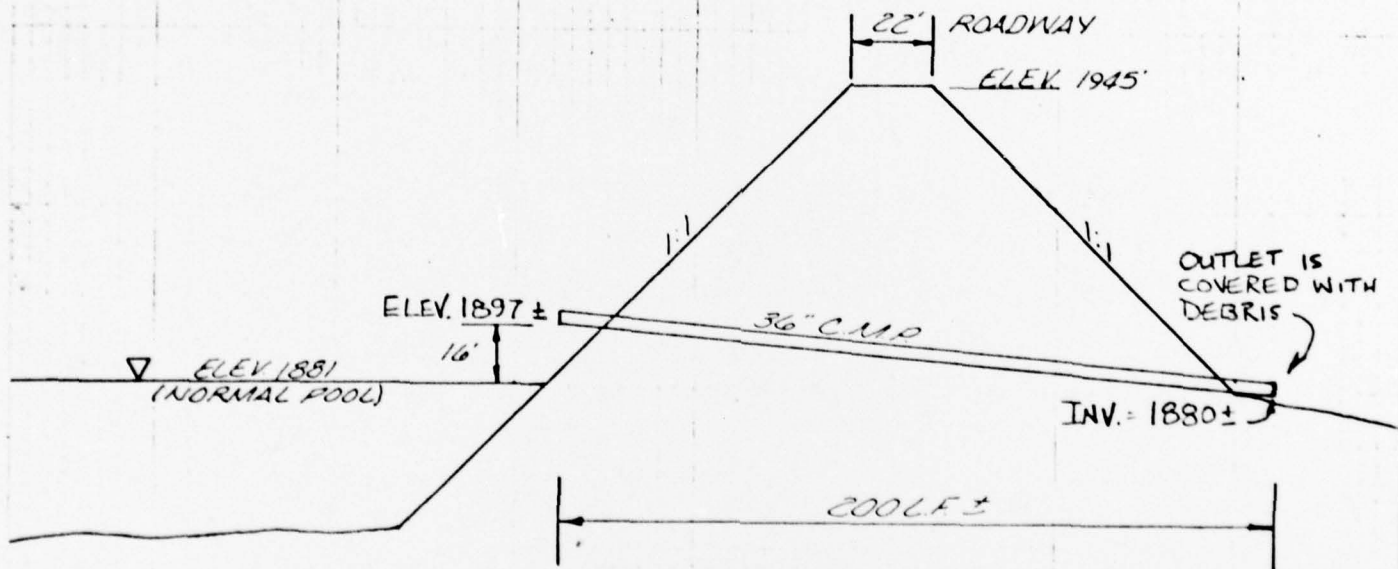
SCALE: 1" = 50'
DRAWN: FESSLER
CHECKED: ROOP
PLATE NO. 3

SECTION THROUGH DAM AT OUTLET
PIPE

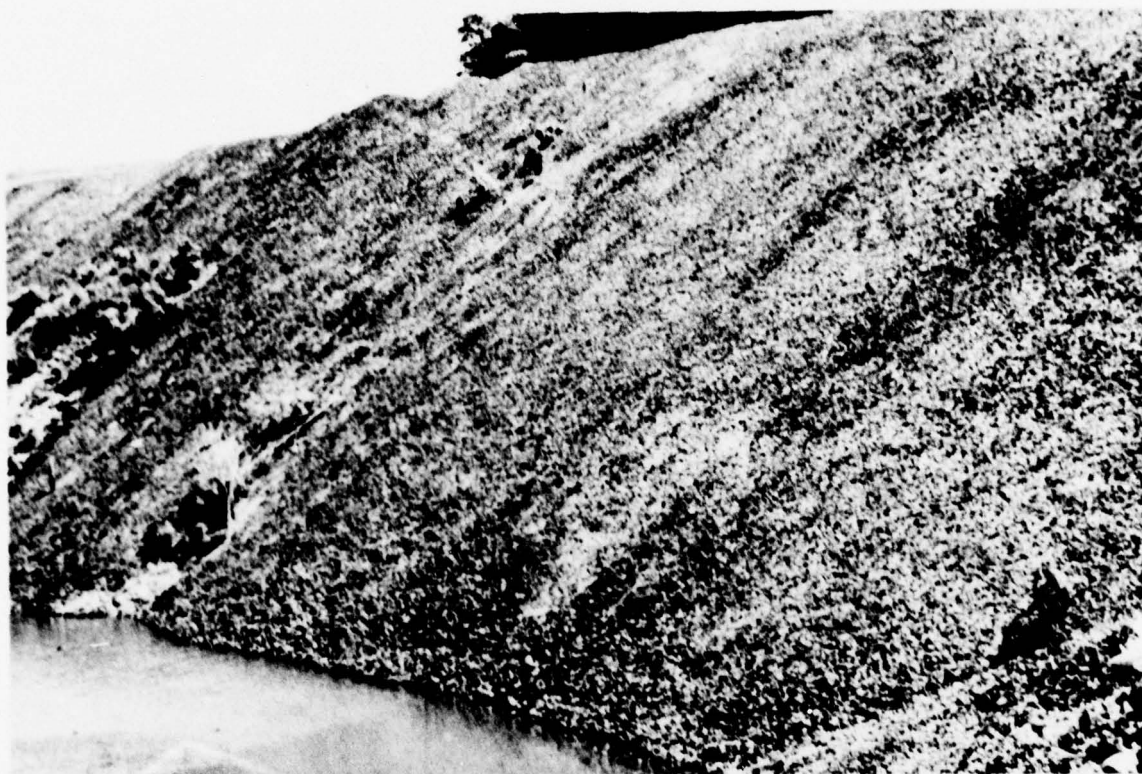
VIEW OF DAM SLOPE
FRESH WATER POND

AT UPSTREAM FACE OF MOSS MINE #1

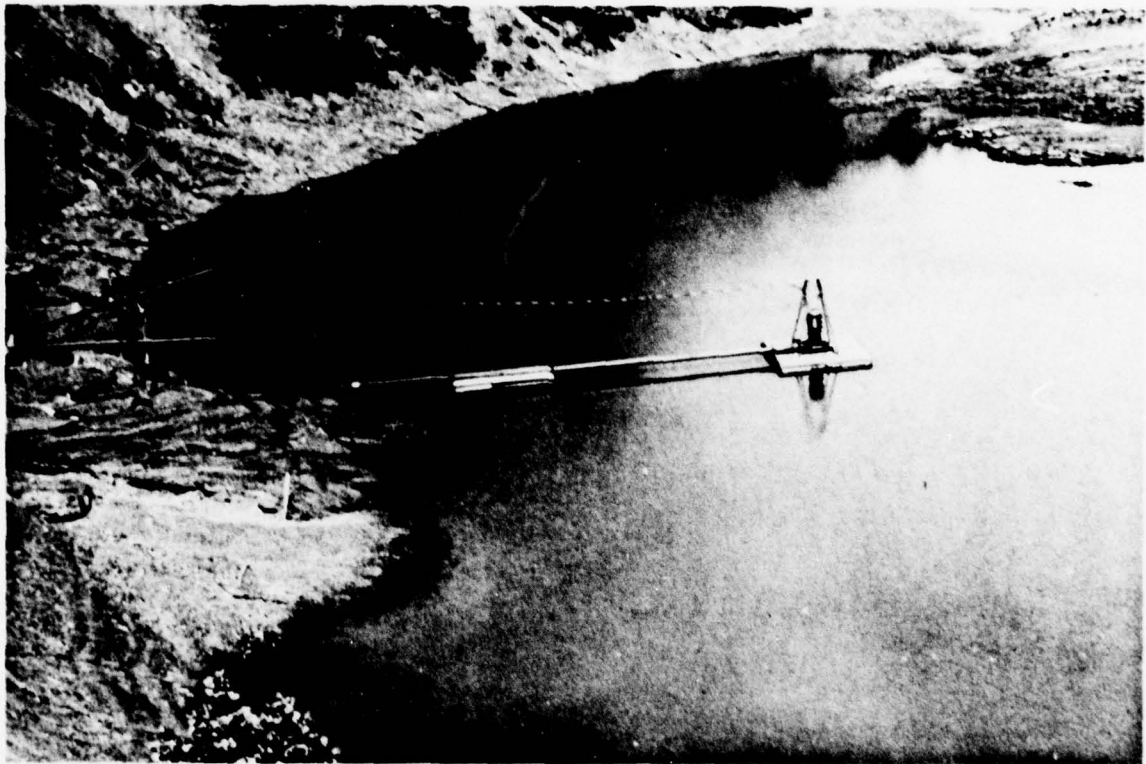
VIEW OF PUMP FROM TOP OF DAM AT MOSS MINE #1
FRESH WATER POND

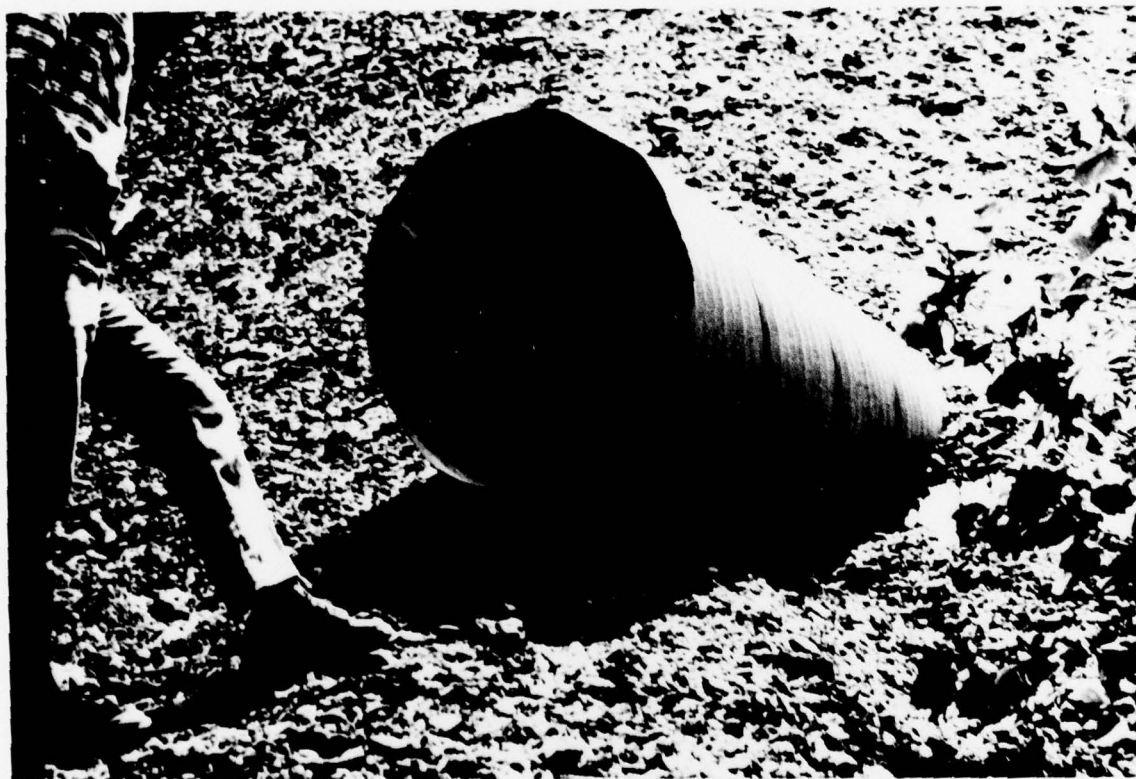
3.1.2 Dam and Spillway: The spillway consists of an ungated 36" CMP located 16 feet above normal pool elevation. The pipe is in good condition but is blocked by mine waste at the outlet.

PRINCIPAL SPILLWAY MOSES MINE #1 FRESH WATER POND

3.2.1 Dam and Spillway: The spillway was blocked on the outlet side by mine waste and this should be removed. The pipe is reportedly in good condition. The severe embankment erosion encountered on the left downstream slope was not considered hazardous at the time of inspection and it need not be corrected if the pond is abandoned in 1980. Otherwise, it is recommended that areas be backfilled and compacted since continued erosion over a long period of years could create a condition detrimental to the integrity of the dam. Seepage observed near the left downstream abutment is not believed to be related
